Manhole Inspection Summary

Manhole # S69M__031MH

Insp Date: **1/29/08 12:37 PM**

Location Address: **1102 Bethlehem Ave.**

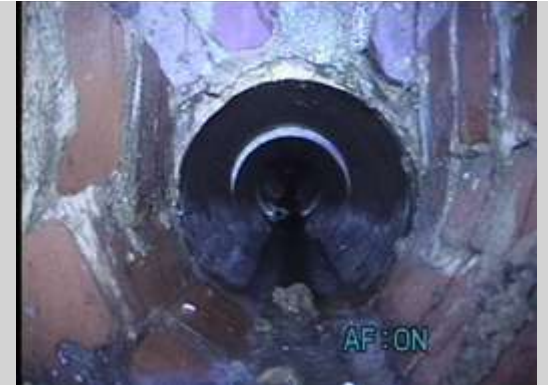
12 O'Clock Outflow

8 in. Circular Gravity Sewer
Pipe Out @ 12 O'Clock

Pipe Height: **8.4** (in.) Rod and Bar (Angled)

Pipe Material: **Clay** ☐ Pipe Lined

Invert Depth: **9.63** (ft.) Flow Characteristics: **None**

Infiltration: **None** Pipe Seal Cond: **Sound**

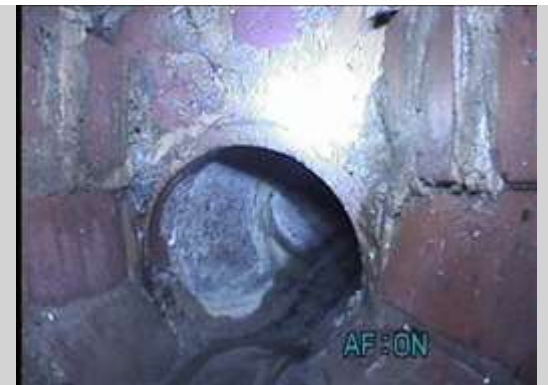
9 O'Clock Inflow

6 in. Circular Gravity Sewer

Pipe In @ 9 O'Clock

Pipe Height: **6** (in.) Rod and Bar (Angled)
Pipe Material: **Clay** ☐ Pipe Lined
Invert Depth: **9.63** (ft.) Flow Characteristics: **None**
Deposits: ☒ None ☐ Mud ☐ Sludge ☐ Debris ☐ Grease
Silt Depth: (in.) Deposits Extent:
Infiltration: **None** Pipe Seal Cond: **Sound**
